Manhole Inspection Summary

Manhole # S61K__002MH

Insp Date: **3/25/08 11:02 AM**

Location Address: **800 Quail St.**

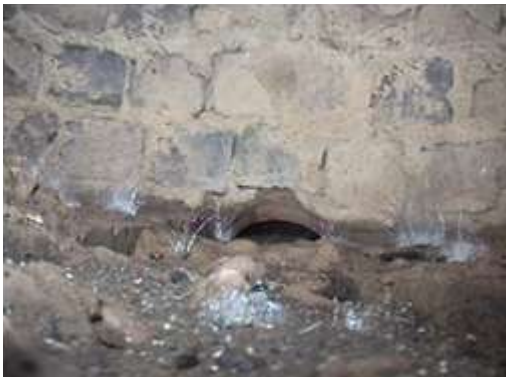
Abandoned 9 O'Clock

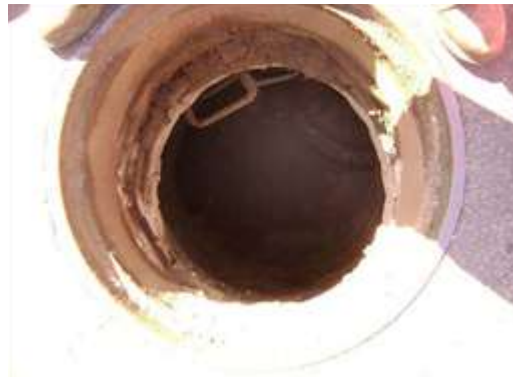
Defect 5

Channel has been filled in, in front of pipe

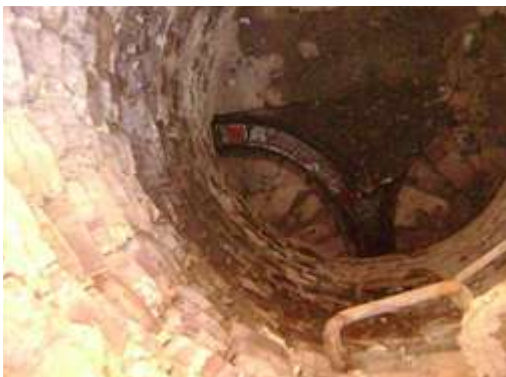
Defect 4

Frame Offset: **3** (in.) Condition: ☐ Sound ☐ Cracked ☒ **Leaks**

Frame offset defect

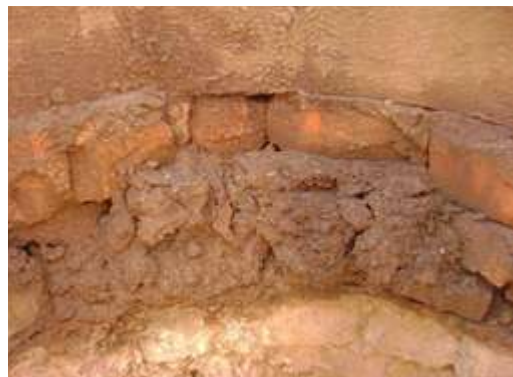
Defect 3

Infiltration at bench

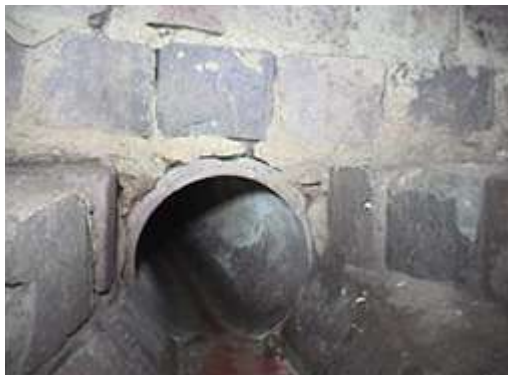
Defect 2

infiltration

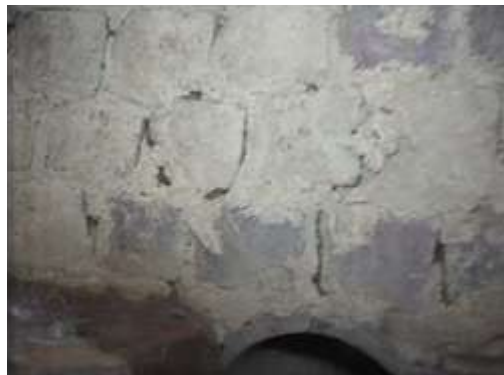
Defect 1

Cracked pipe seal incoming 3 o'Clock

Pipe Height: **6** (in.) Rod and Bar (Angled)
Pipe Material: **Clay** ☐ Pipe Lined
Invert Depth: **8.50** (ft.) Flow Characteristics: **None**
Deposits: ☒ None ☐ Mud ☐ Sludge ☐ Debris ☐ Grease
Silt Depth: (in.) Deposits Extent:
Infiltration: **Evidence** Pipe Seal Cond: **Cracked**

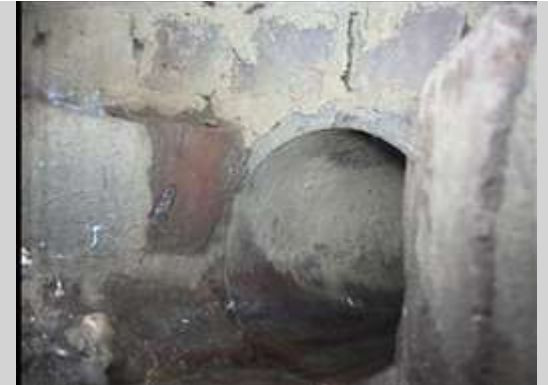
12 O'Clock Outflow

8 in. Circular Gravity Sewer
Pipe Out @ 12 O'Clock

Pipe Height: **8.4** (in.) Rod and Bar (Angled)
Pipe Material: **Clay** ☐ Pipe Lined
Invert Depth: **8.88** (ft.) Flow Characteristics: **None**
Deposits: ☒ None ☐ Mud ☐ Sludge ☐ Debris ☐ Grease
Silt Depth: (in.) Deposits Extent:
Infiltration: **None** Pipe Seal Cond: **Sound**

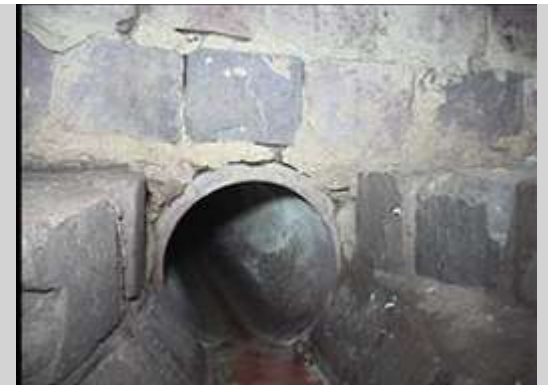
3 O'Clock Inflow

6 in. Circular Gravity Sewer
Pipe In @ 3 O'Clock
